Award Category

Monitoring-Based Commissioning

MBCx at CSU Long Beach University Music Center

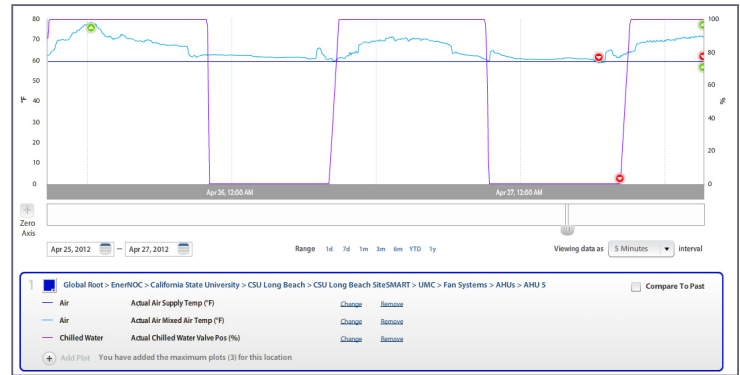
ments. The flat line (blue) indicates that the sensor is reading the same value regardless of the actual temperature, which is evidence of a poorly functioning supply air temperature sensor. When the sensor is performing properly, the trend line will fluctuate with the temperature of conditioned supply air, similar to the trend line in the mixed air temperature sensor (light blue line). The screen also shows the chilled water valve reading as a flat line either fully open or fully closed, another indication of a sensor malfunction. Since the system has an economizer, the chilled water valve should fluctuate based on the amount of free cooling from outside air being supplied. The example illustrates the value of good visualization tools, and the need to regularly verify sensor calibration and the status of key water valves.

Screen image from the University Music Center's diagnostic software. See text for explanation. Image: EnerNOC.

The screen capture on the following page illustrates how an effective building operator can use such diagnostic tools to translate data analysis into actionable repairs and improve-
